HISTORIC BUILDING INVENTORY RECORD

SUBJECT Littleton Historic Resources Survey, NAME: 2000-01, SHF#2000-01-069		COUNTY: Arapahoe	CITY: Littleton	STATE ID NO.: 5AH1673
		TEMP. NO: 207716315007		
CURRENT BUILDING NAME:		OWNER: OHLER, DAVID C & PAULA M JT TEN		
ADDRESS: 5736 S BEMIS ST LITTLETON, 80120		005736 S BEMIS ST LITTLETON CO 80120-2009		
HISTORIC NAME: Bechtel Residence		TOWNSHIP: 5S RANGE: 68W SECTION:16 SW 1/4 SW 1/4		
DISTRICT NAME:		USGS 7.5' QUAD. NAME: Littleton, Colo. YEAR: 1965, r. 1994		
BLOCK: N/A LOT(S): 13p,14		ADDITION: Comstock's Add YEAR OF ADD.: 1891		
FILM ROLL NO.: 00-29 BY: Roger Whitacre	NEGATIVE NO.: 22	LOCATION OF NEGATIVES: Littleton Hist. Mus.	DATE OF CONSTRUCTION: ESTIMATE: ACTUAL: 1908 SOURCE: Arapahoe County Assessor	
ATTACH PHOTOGRAPH HERE			PRESENT USE: Domestic/Single Dwelling	
			HISTORIC USE: Domestic/Single Dwelling	
			CONDITION: Good	
			EXTENT OF ALTERATIONS: Minor DESCRIBE: Transom covered up. Porch supports altered (?). CON'T.? No

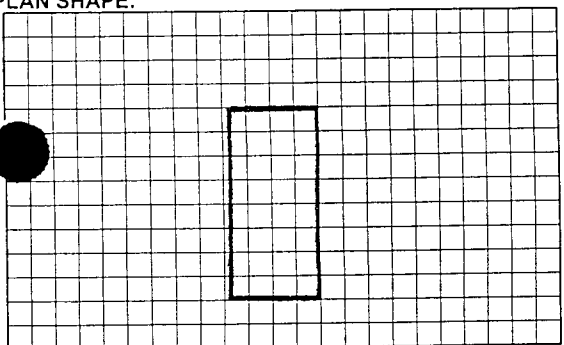
PLAN SHAPE:

STYLE: Late Victorian		STORIES: 1 1/2		
MATERIALS: Wood		SQ. FOOTAGE: 954		
ARCHITECTURAL DESCRIPTION: One-and-a-half-story frame dwelling with complex roof with hipped roof and intersecting gables; composition roofing and overhanging eaves. Walls clad with horizontal lap board siding with corner boards. Front gable face and north gable face clad with decorative shingles and have small windows. Off-center entrance with wood flush panel door has covered up transom. Large 1/1-light double-hung sash windows on either side of entrance. Paired 1/1-light windows with lintel trim on north. Half-hipped roof porch with small pediment above entrance has square supports with chamfered edges; concrete porch steps; wood porch floor. Stone retaining wall and large maple trees. CON'T.? No			MOVED? No DATE(S) OF MOVE:	
			NATIONAL REGISTER ELIGIBILITY: INDIVIDUAL? Not Eligible CONTRIBUTING TO DISTRICT?	
			LOCAL LANDMARK DESIGNATION? No NAME: DATE:
